FORMER TUSCALOOSA CHEVROLET SITE

A BROWNFIELD REDEVELOPMENT SUCCESS

Report of Site Assessment and Cleanup

Former Tuscaloosa Chevrolet Site - 115 Greensboro Avenue
Tuscaloosa, Tuscaloosa County, Alabama

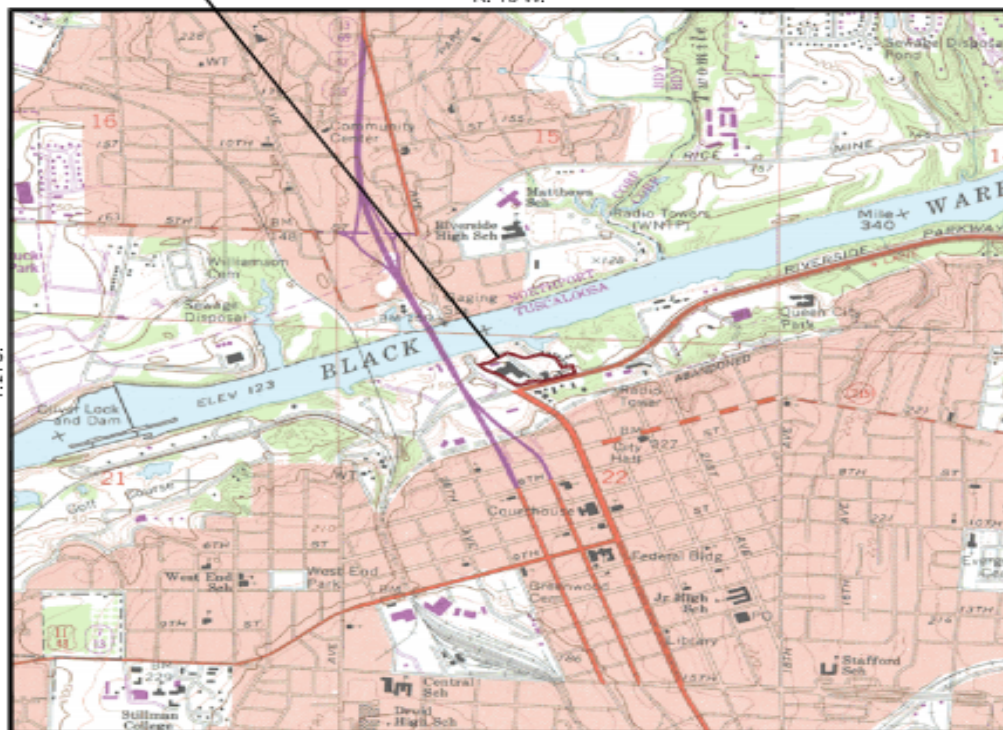
Figure 1. Site Location and Topographic Map

NE $\frac{1}{4}$, NW $\frac{1}{4}$, and NW $\frac{1}{4}$, NE $\frac{1}{4}$, Sec. 22, T. 21 S., R. 10 W., of the Tuscaloosa, Ala. 7.5 Minute Quadrangle Map

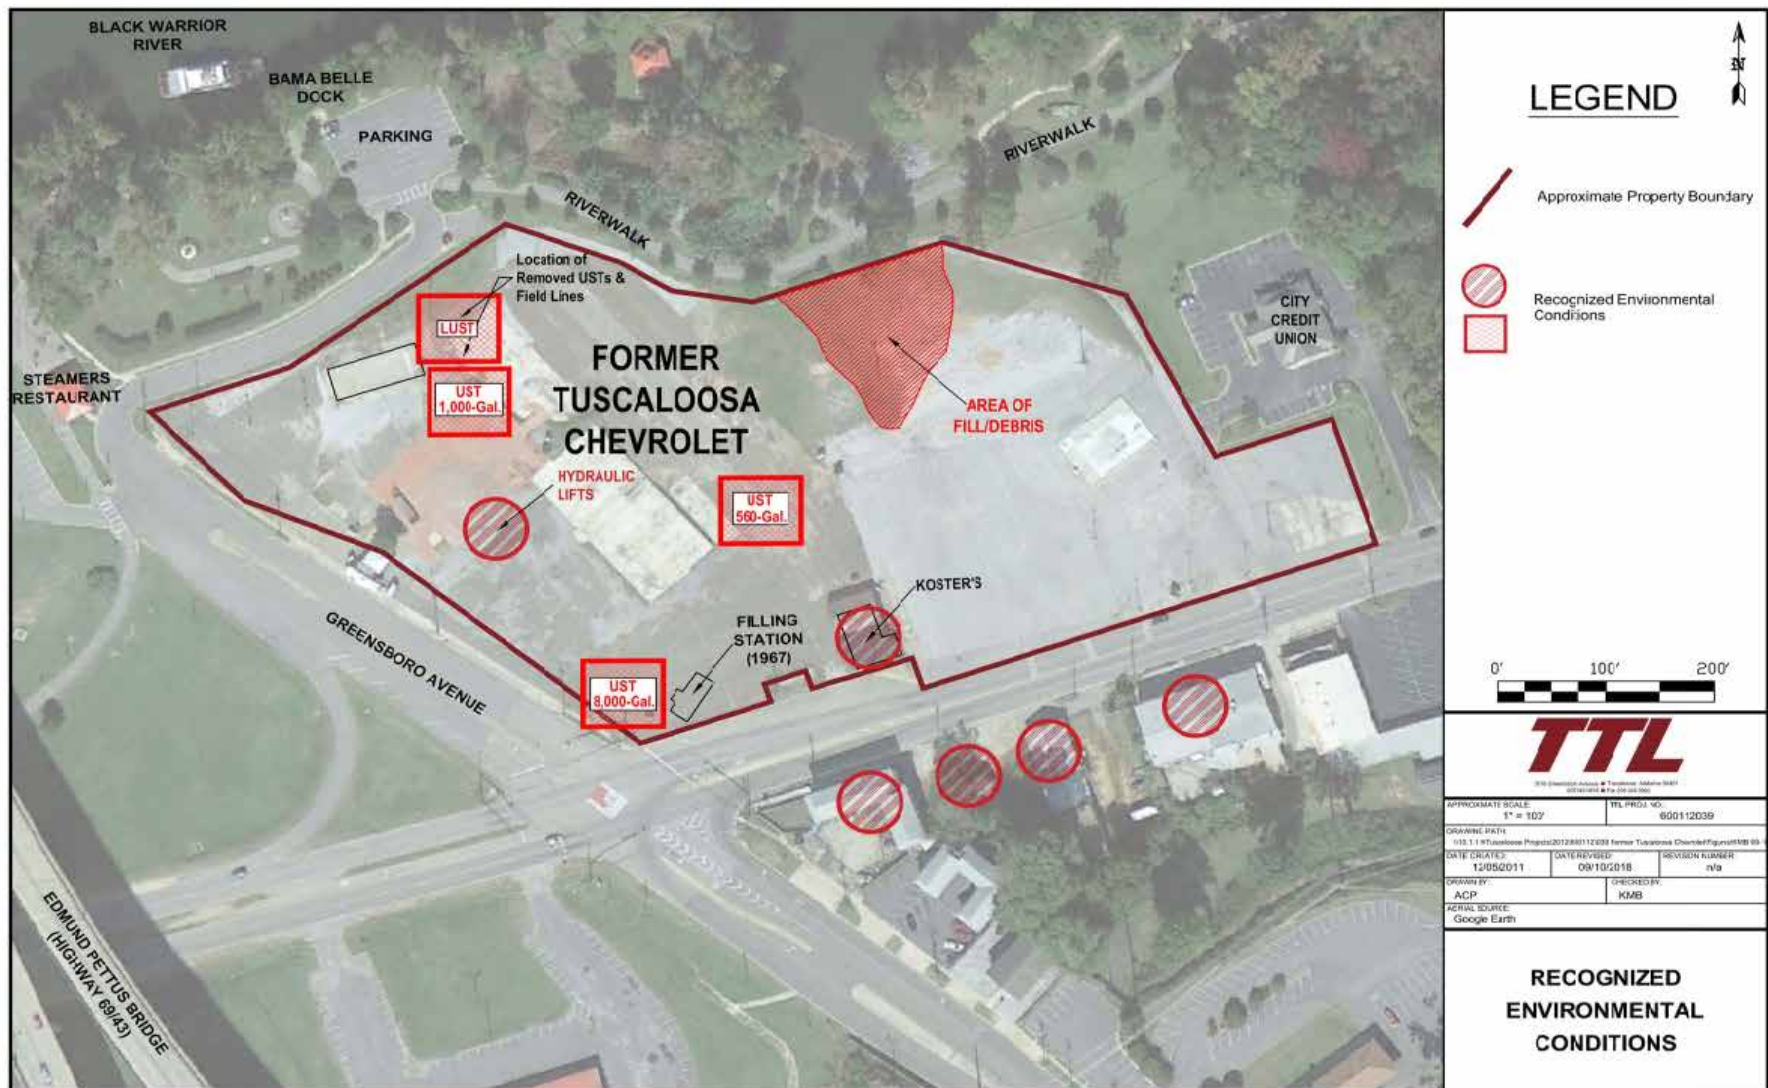
Recognized Environmental Conditions

- On-site, active LUST incident - NW section of property
- On-site areas of dumping on NE section of property
- On-site, Koster's Radiator Shop (1947 – 2013)
- On-site, unregistered, 560-gallon UST
- On-site, unregistered, 1,000-gallon UST
- On-site, former service station – NE intersection of Greensboro Avenue and Jack Warner Parkway
- On-site, in-ground hydraulic lifts
- Off-site, upgradient (across JW Parkway):
 - Drycleaners
 - Filling Station
 - Paint Shop

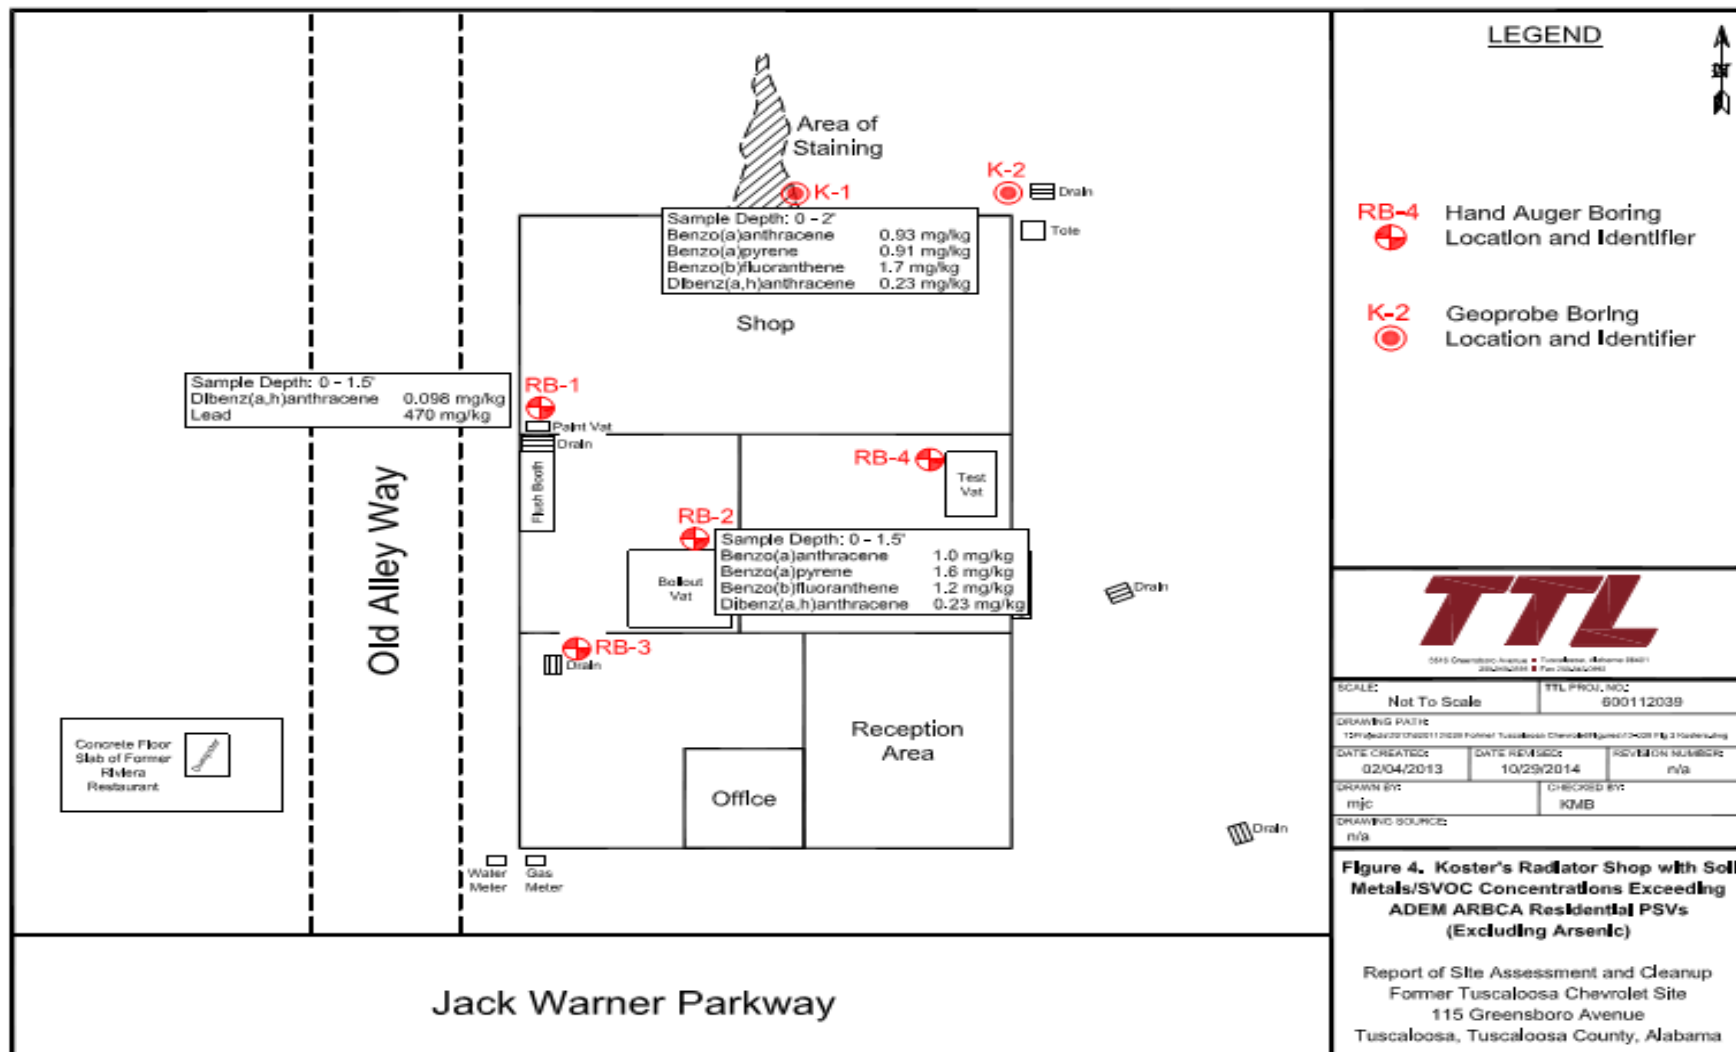
Koster's Focused Investigation

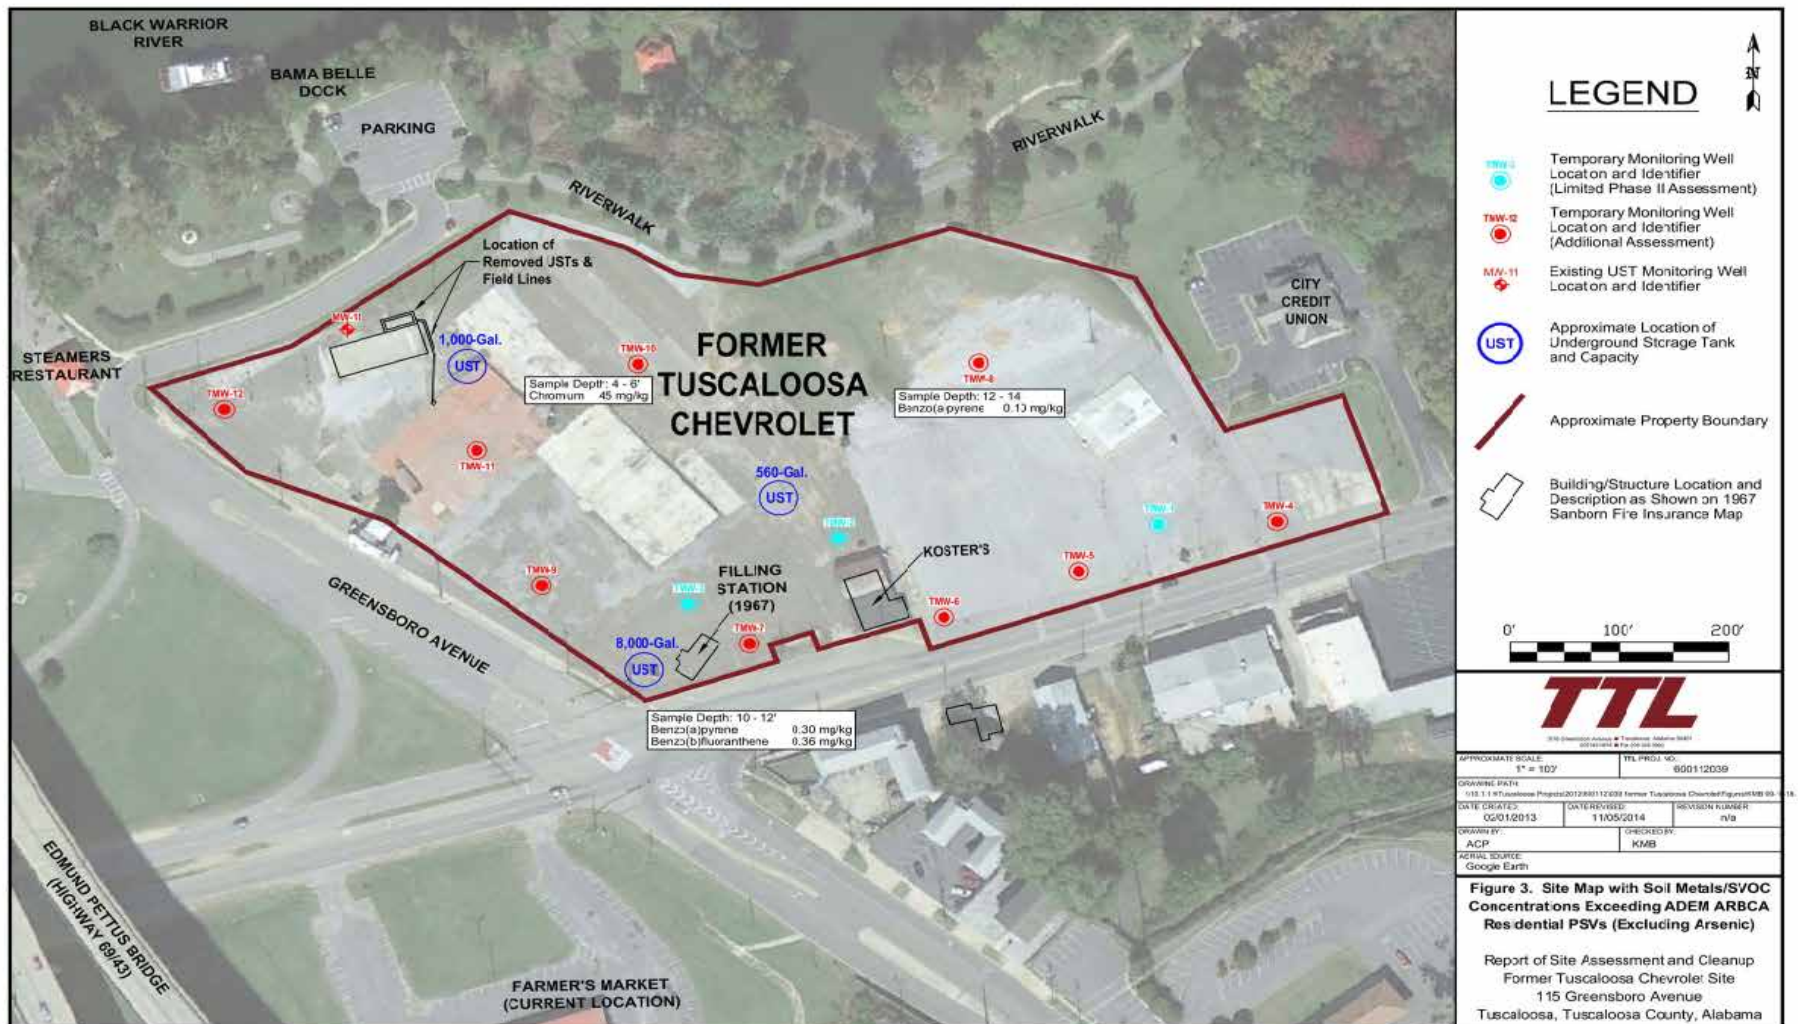
Focused Phase II Assessment (Soil – Metals and SVOCs)

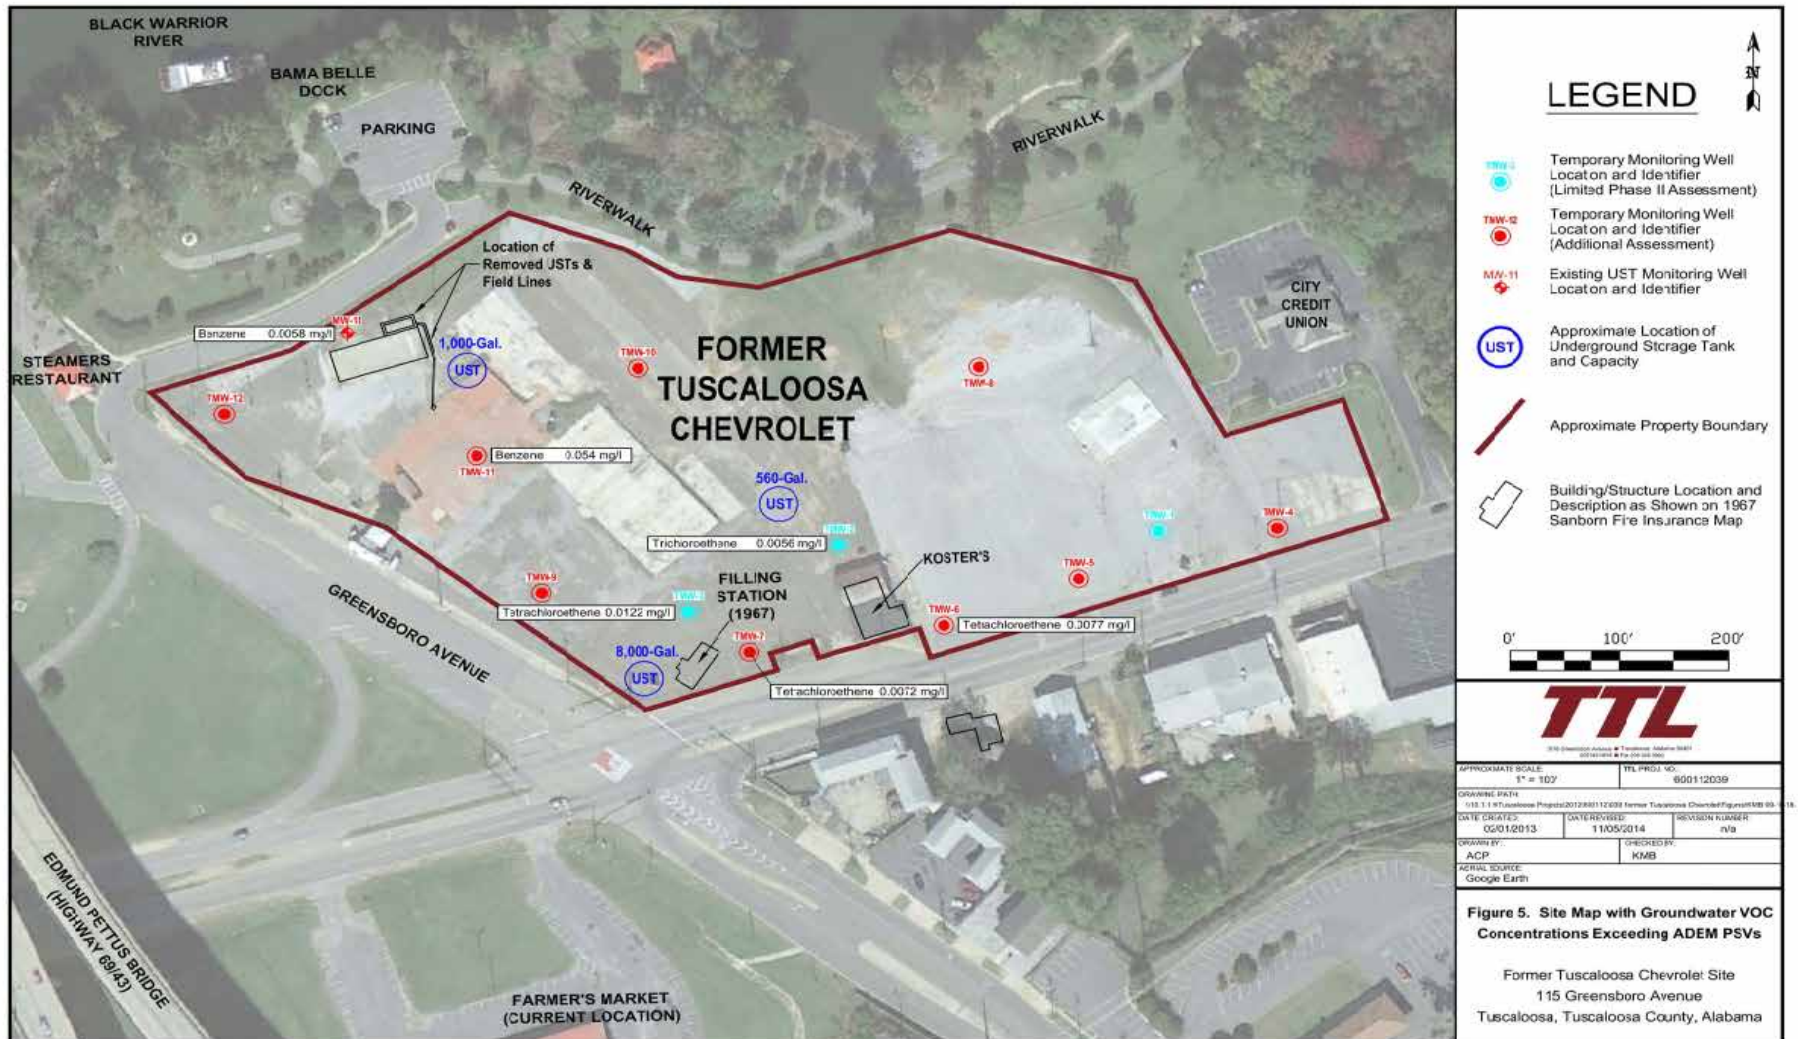
Focused Phase II Assessment (Groundwater – VOCs)

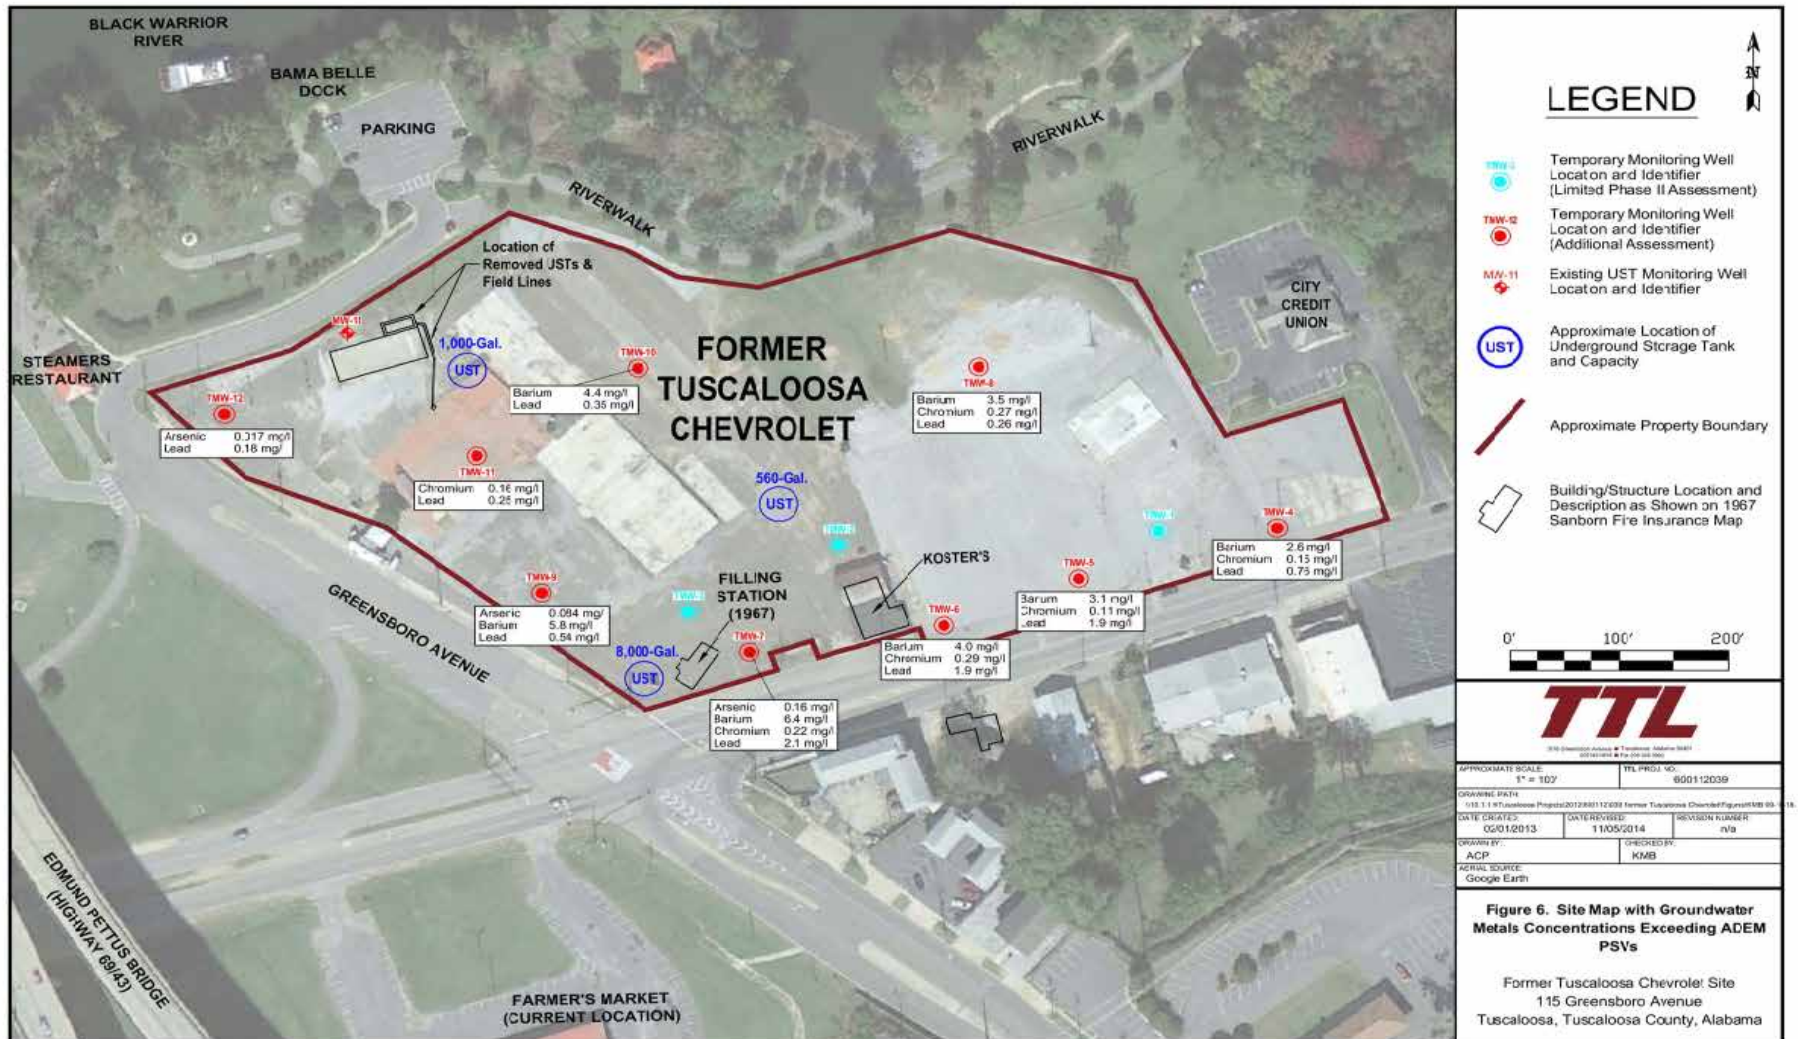
Focused Phase II Assessment (Groundwater – RCRA Metals)

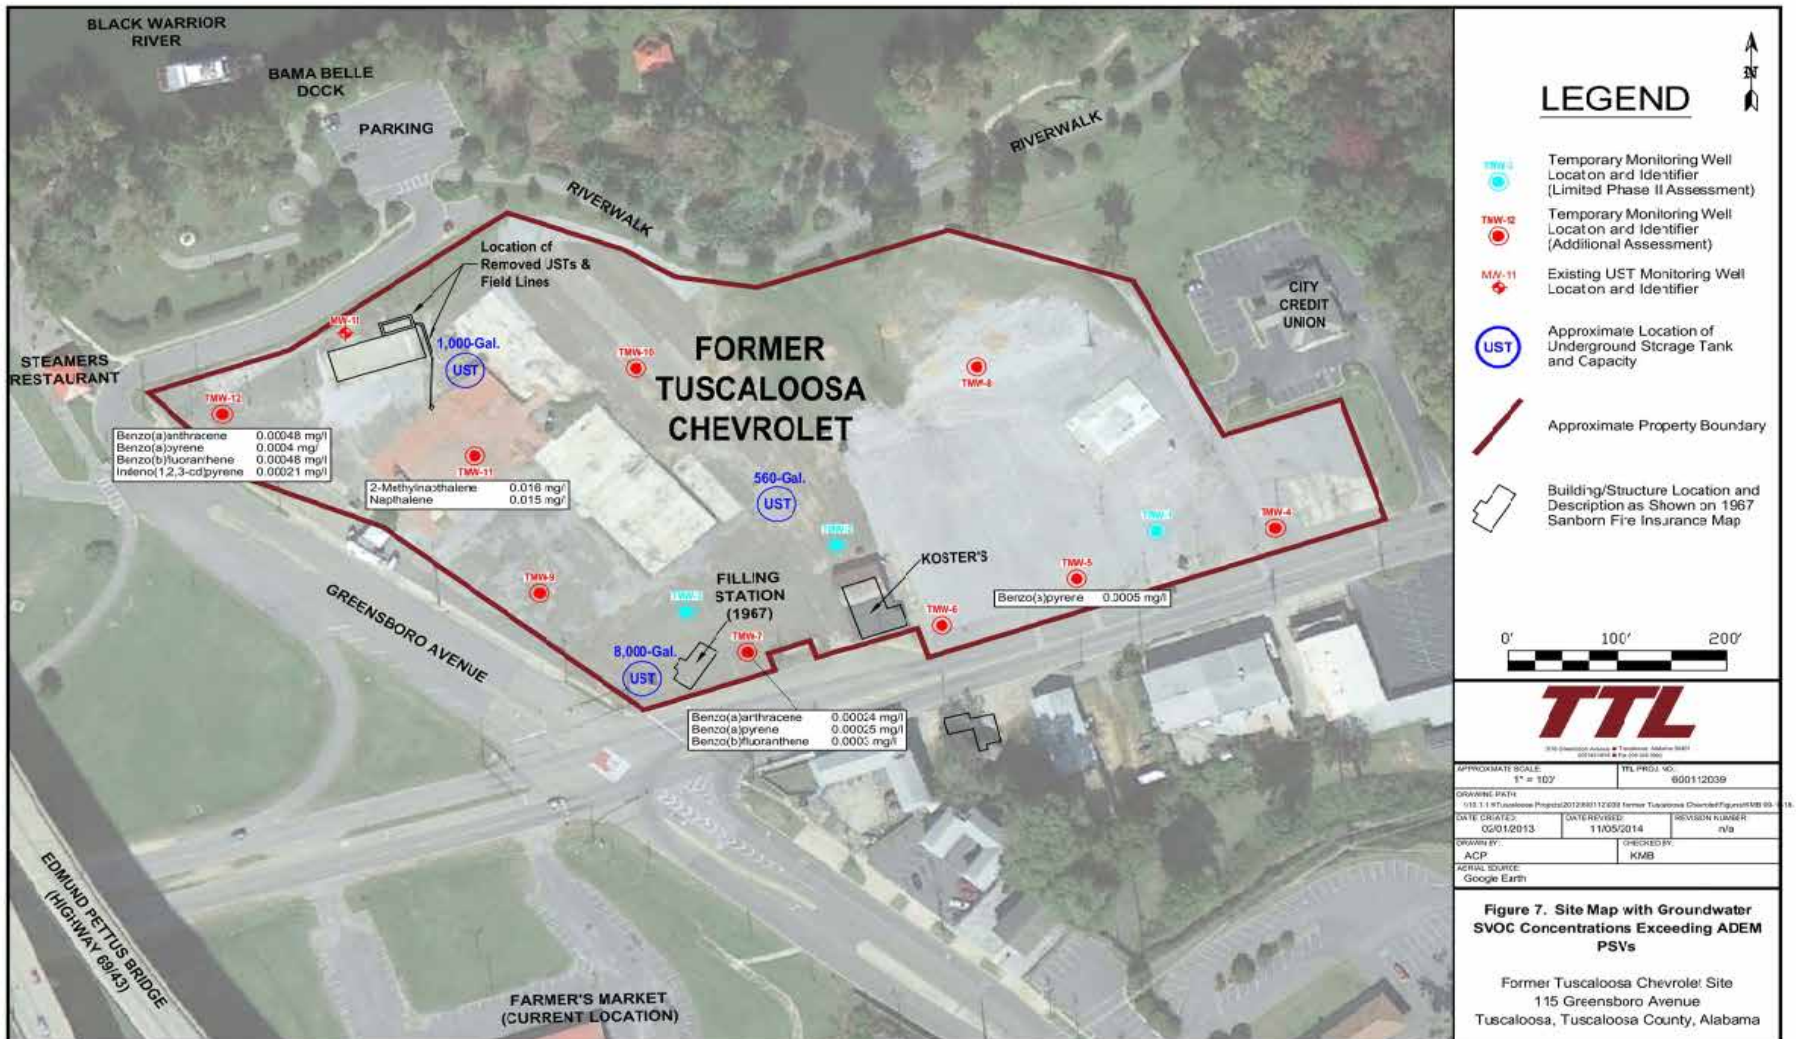
Focused Phase II Assessment (Groundwater – SVOCs)
